Realty Home Inspections, Inc. P.O.BOX 772617 Realty P.O.BOX 772617
Home Inspections, Inc. Orlando, Florida 32877-2617 Tel. 407-448-4497

# Inspection Report

1 Sample Dr Orlando, Florida 12345

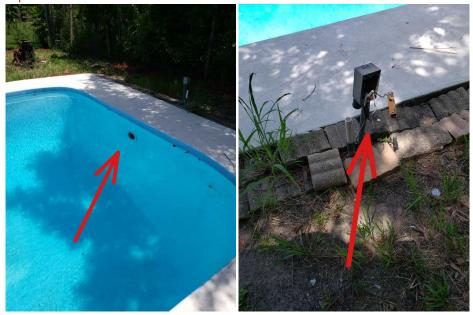
13. Defective

Pool light Submercible - Not functional. A qualified contractor should further evaluate and estimate repairs

1. Behind home Swimming Pool Pool light Submercible - Not functional. A qualified contractor should further evaluate and estimate repairs

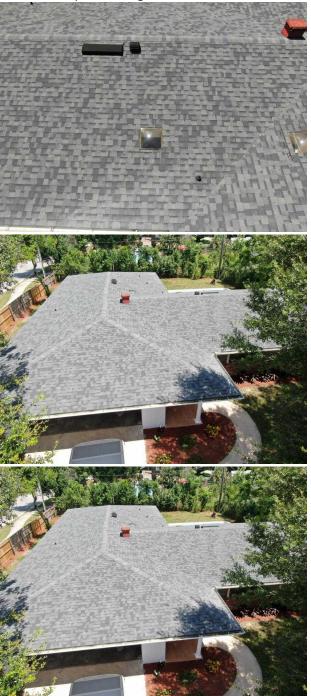
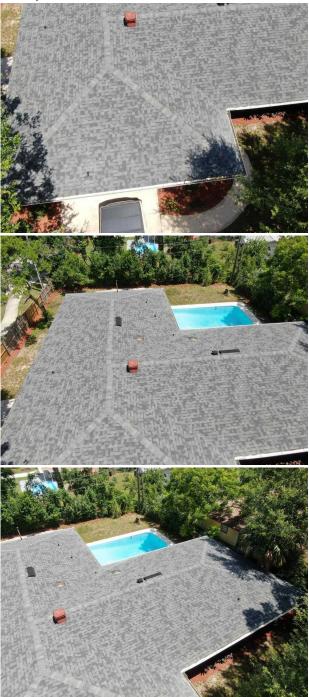
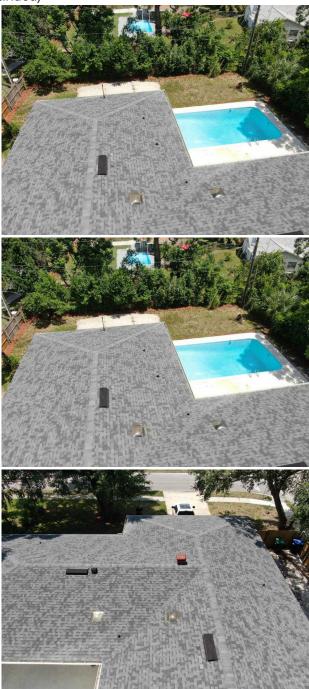
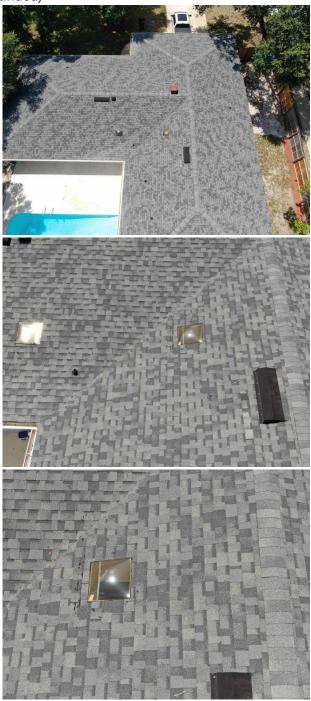
3. Acceptable Material: Asphalt shingle - Permit # T19003279 Issue date: 03/14/19

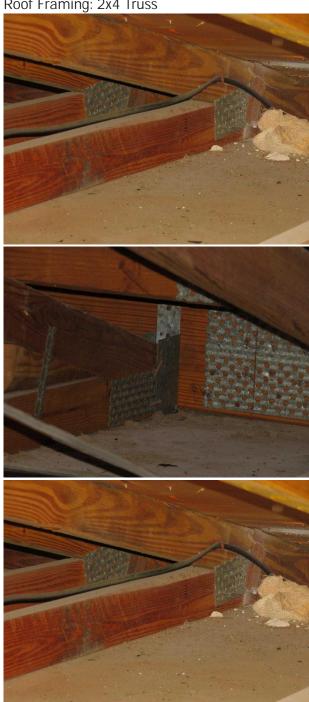
- 1. Method of Inspection: From the attic access
- 2. Acceptable Unable to Inspect: 30%
- 3. Acceptable Roof Framing: 2x4 Truss

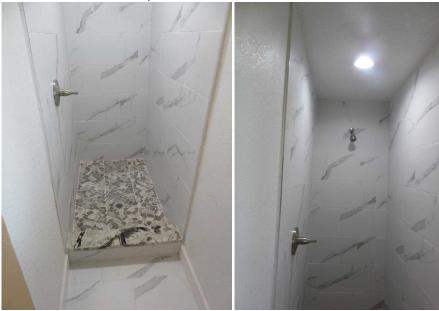
10. Acceptable Shower/Surround: Tile pan and surround

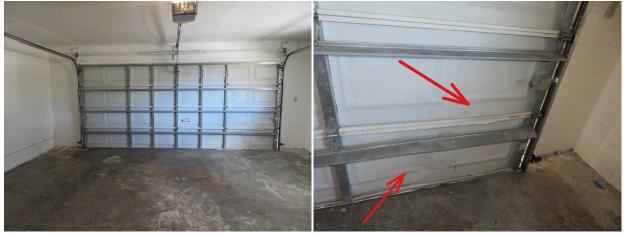
2. Attached Garage Garage Doors: Aluminum - Dents noted in the door panel

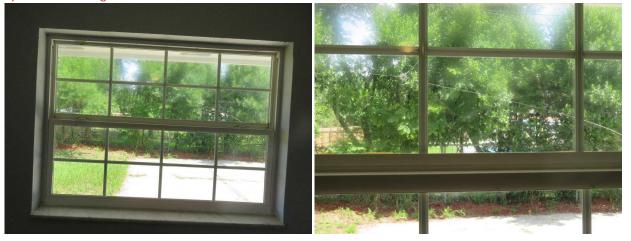
15. Bedroom # 3 Bedroom Windows: Vinyl single hung - A qualified glazier is recommended to evaluate and estimate repairs, Broken glass
